# VA DEQ Recon Inspection Report

<b>FACILITY NAME:</b> Dominion – Possum Point Power Station		<b>INSPECTION DATE:</b> August 7, 2015	
<b>PERMIT No.:</b> VA0002071		<b>INSPECTOR:</b> Susan Mackert	
<b>TYPE OF FACILITY:</b> <div style="display: flex; justify-content: space-between; padding: 0;"> <div style="width: 45%;"> <input type="checkbox"/> Municipal  <input checked="" type="checkbox"/> Industrial  <input type="checkbox"/> Federal  <input type="checkbox"/> HP    <input type="checkbox"/> LP         </div> <div style="width: 45%;"> <input checked="" type="checkbox"/> Major  <input type="checkbox"/> Minor  <input type="checkbox"/> Small Minor         </div> </div>		<b>REPORT DATE:</b> August 11, 2015	
<b>TIME OF INSPECTION:</b>		1:20 pm Arrival	3:15 pm Departure
<b>TOTAL TIME SPENT:</b>		3.5 hours	
<b>PHOTOGRAPHS:</b> <input checked="" type="checkbox"/> Yes <input type="checkbox"/> No		<b>UNANNOUNCED INSPECTION?</b> <input type="checkbox"/> Yes <input checked="" type="checkbox"/> No

On August 6, 2015, Dominion self-reported an overflow which had occurred from a frac tank being utilized for ash pond closure at the Possum Point Power Station. A site visit was conducted on August 7,

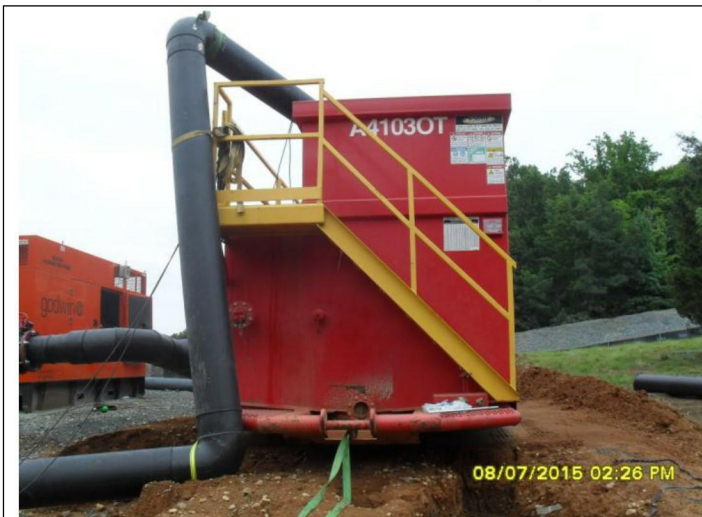
- The frac tank (Photo 1) is being utilized to hold water from the Oily Waste Pond (Internal Outfall 502) and groundwater wells located in Ash Pond E which is then pumped to Ash Pond D as part of the closure process.

- On August 6, 2015, at approximately 5:45 am, the frac tank was observed by Dominion staff to be overflowing. Upon investigation it was discovered that the floats on both the primary and back-up pumps failed causing the overflow. By approximately 6:00 am, the pumps were switched to manual mode and normal flow of water to Ash Pond D resumed. A cause for the failures has not been determined. It is not known how long the overflow had been taking place. An estimate of the volume of the overflow was not available.

Photo 1. Frac tank.

- At the time of the site visit, alarms were being installed on both the primary and back-up pumps which will notify selected staff via telephone if there is a problem with the pumps. Additionally, audible and/or visual alarms will be installed on the pumps to alert staff. Staff will now be at this site at all times.

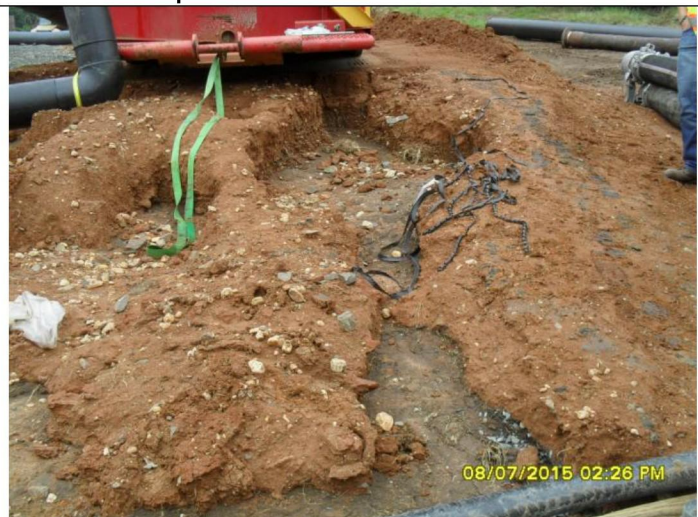
- Flow from the frac tank left the active work area (Photos 2 – 3) and followed a ditch adjacent to Possum Point Road (Photo 4) before crossing under Possum Point Road (Photo 5) entering a heavily vegetated area adjacent to Quantico Creek via a Virginia Department of Transportation (VDOT) culvert (Photo 6). It is not known if the overflow from the frac tank entered Quantico Creek. No flow was noted at the time of the site visit.

Photo 2. Area of erosion at overflow point of frac tank.

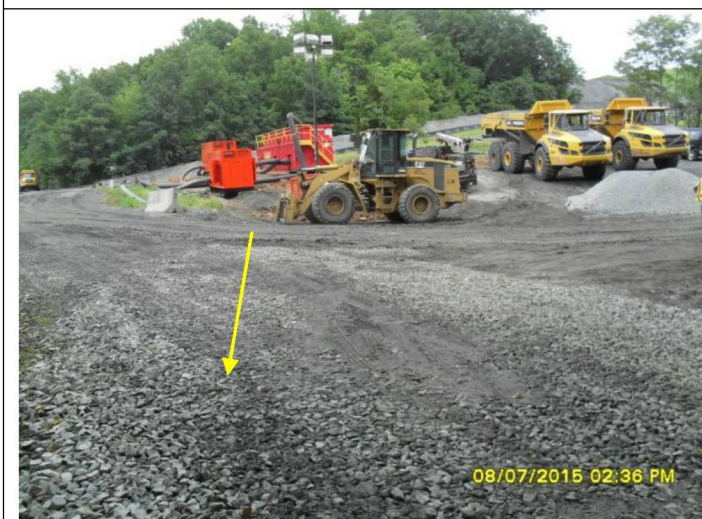
Photo 3. Flow from the frac tank moved in the direction of the arrow towards Possum Point Road.

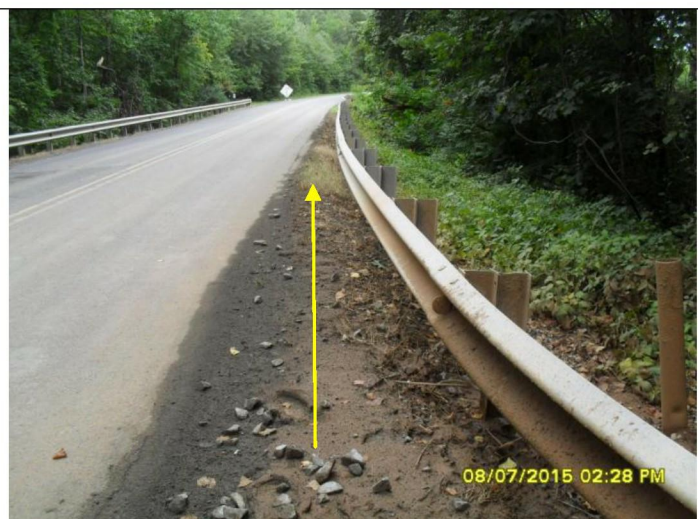
Photo 4. Flow from the frac tank moved in the direction of the arrow along Possum Point Road.

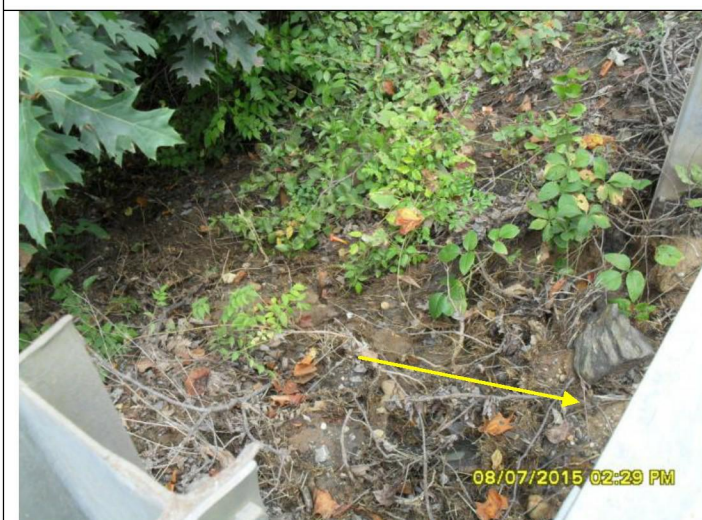
Photo 5. Area where the flow from the frac tank went underneath Possum Point Road. Flow was in the direction of the arrow.

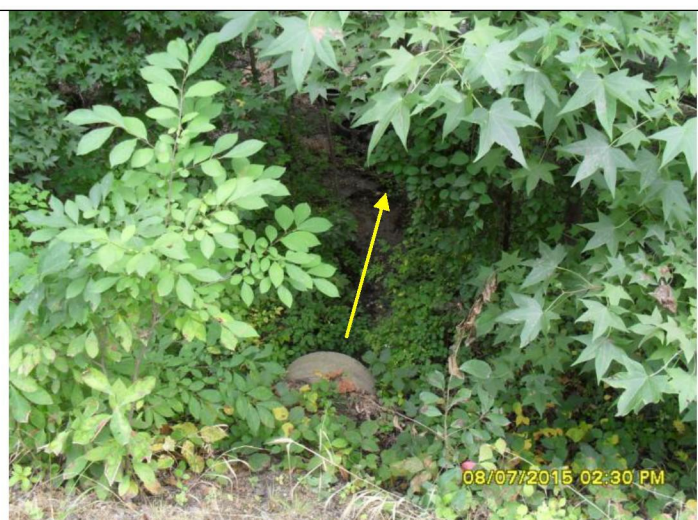
Photo 6. VDOT culvert where flow from the frac tank (Photo 5) discharged to a heavily vegetated area. Flow was in the direction of the arrow towards Quantico Creek.

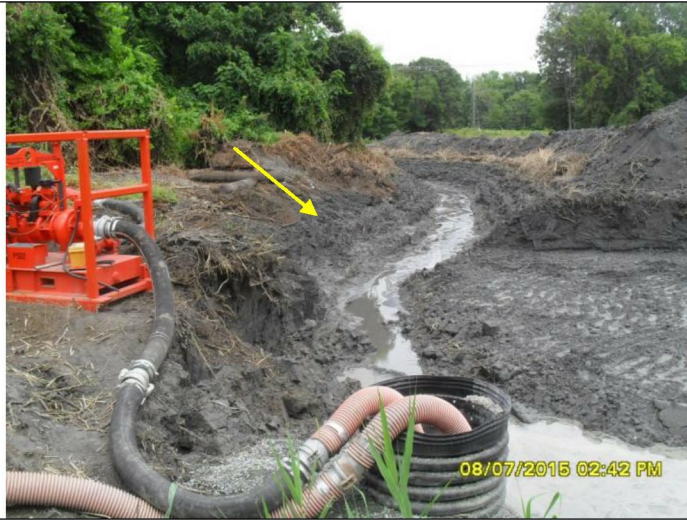
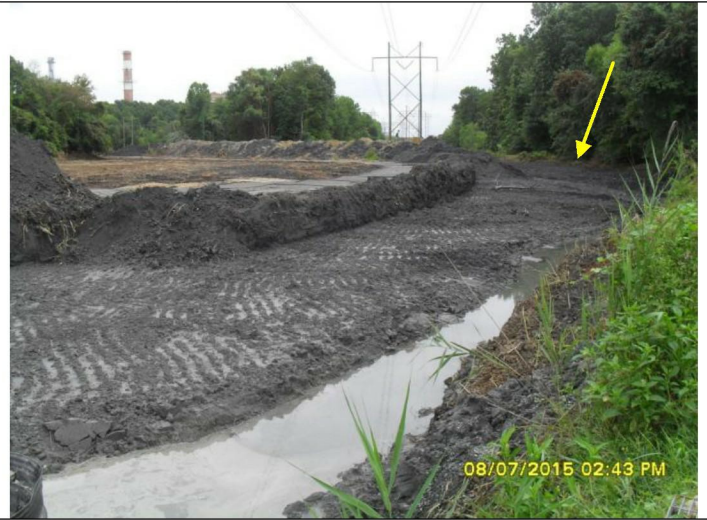
- While on site, DEQ staff also requested to view ash movement at Ash Pond A, Ash Pond B, and Ash Pond C complex. Movement of ash began at this location on August 5, 2015. At the time of the site visit only ash from Ash Pond C was being removed and transported to Ash Pond D (Photos 7 – 8). The decant structure associated with Ash Pond C has been bladdered so that no water can enter the structure. Any flow is diverted to Ash Pond D. Approximately 400 feet associated with Ash Pond C has been rim ditched with an additional 600 – 800 feet being rim ditched to Ash Pond A (Photos 7 – 8).

Photo 7. Combined with Photo 8 shows Ash Pond C. The arrow points towards the rim ditching.

Photo 8. Combined with Photo 7 shows Ash Pond C. The arrow points towards the rim ditching.
